# The Art of the Rebuild

## Gearbox Modifications Protect 1.2 Million Acres of Arkansas Farmland

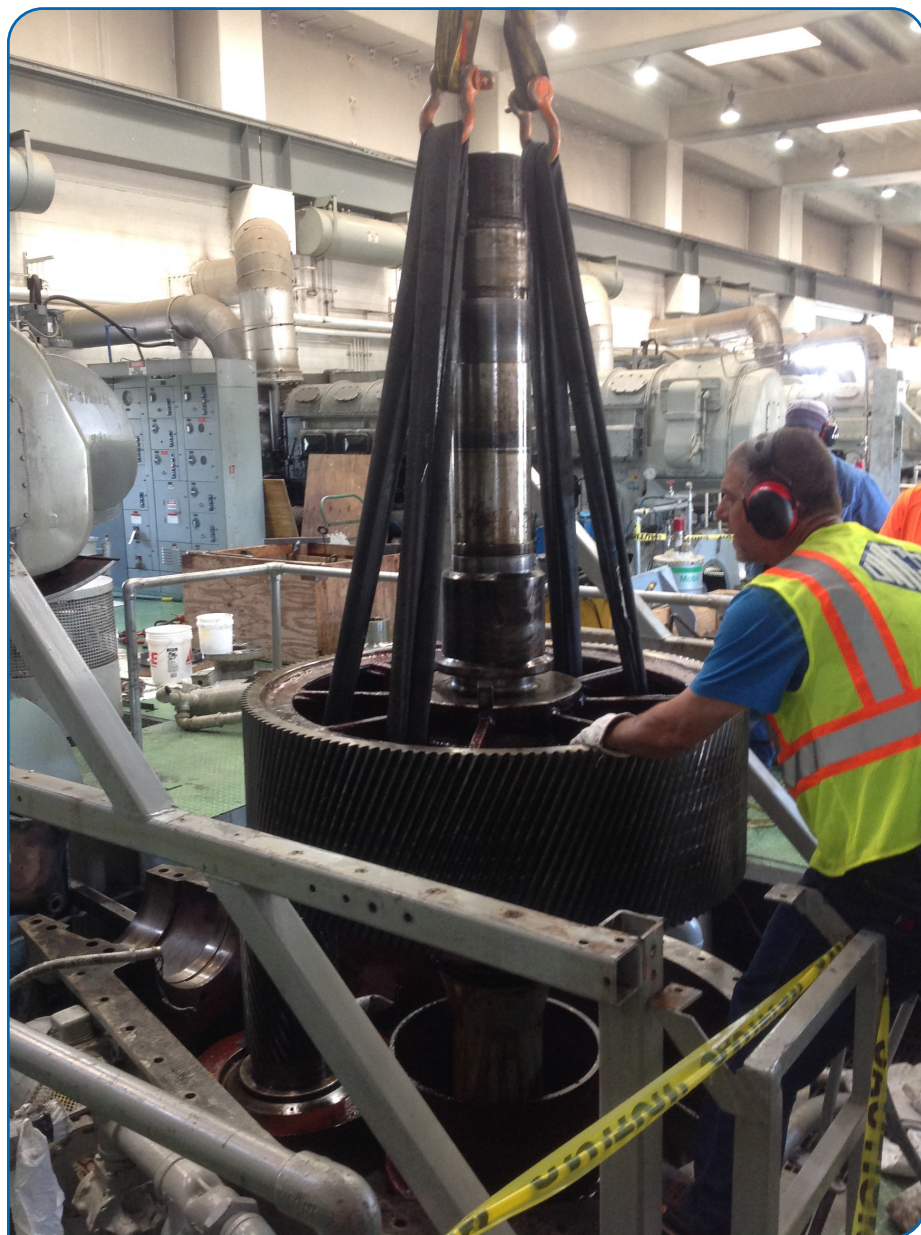
Disassembly and removal of one of the gearboxes.

When the Atlanta Gear Works team brought the gearboxes back to the shop and opened them up, they discovered the repairs would be more involved than expected. And though the gearboxes were identical, the repairs would be different for each one, with a focus on the gears themselves.

For the first gearbox, the team made all new gears, plus a spare set. In addition to the original specs, they identified that the thrust bearing and back-stop needed to be refurbished and the lubrication pumps and coupling disc packs needed to be replaced.

For the second gearbox, they were able to use gears provided by Huxtable. Since the intermediate pinion shaft

had sheared and greatly damaged the gears, to prevent future failures, they made a modification on the gears on that shaft at the point where it broke to reduce stress concentration. They also refurbished the thrust bearings and the backstops to prevent the gearbox from running in both directions.
